TECHNICAL INSPECTION REPORT

366711
U.S.S. PENSACOLA (CCA24)

OPERATION CROSSROADS

PHOTOGRAPHS

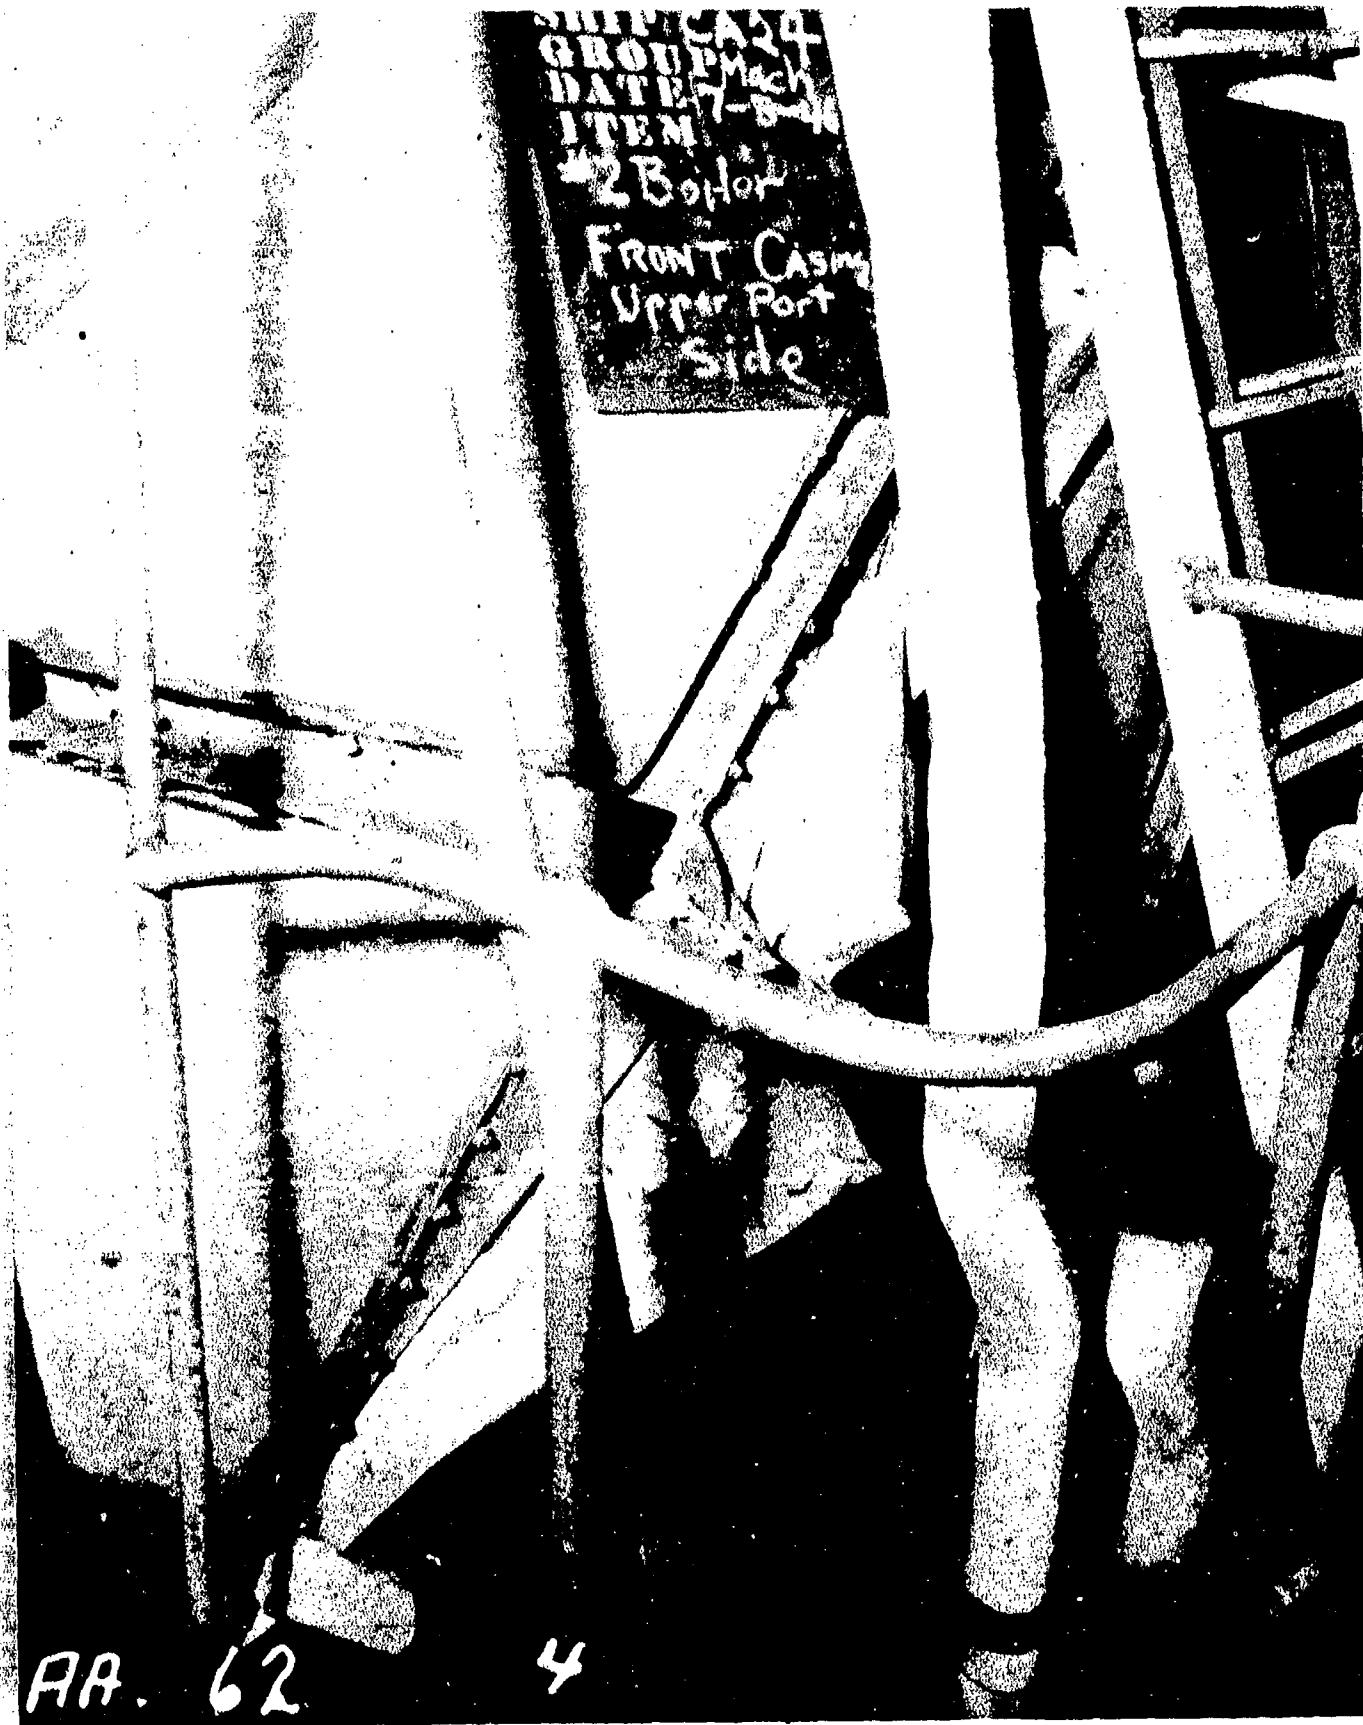
AA-CR-62-1879-4. #2 Boiler, upper front casing.

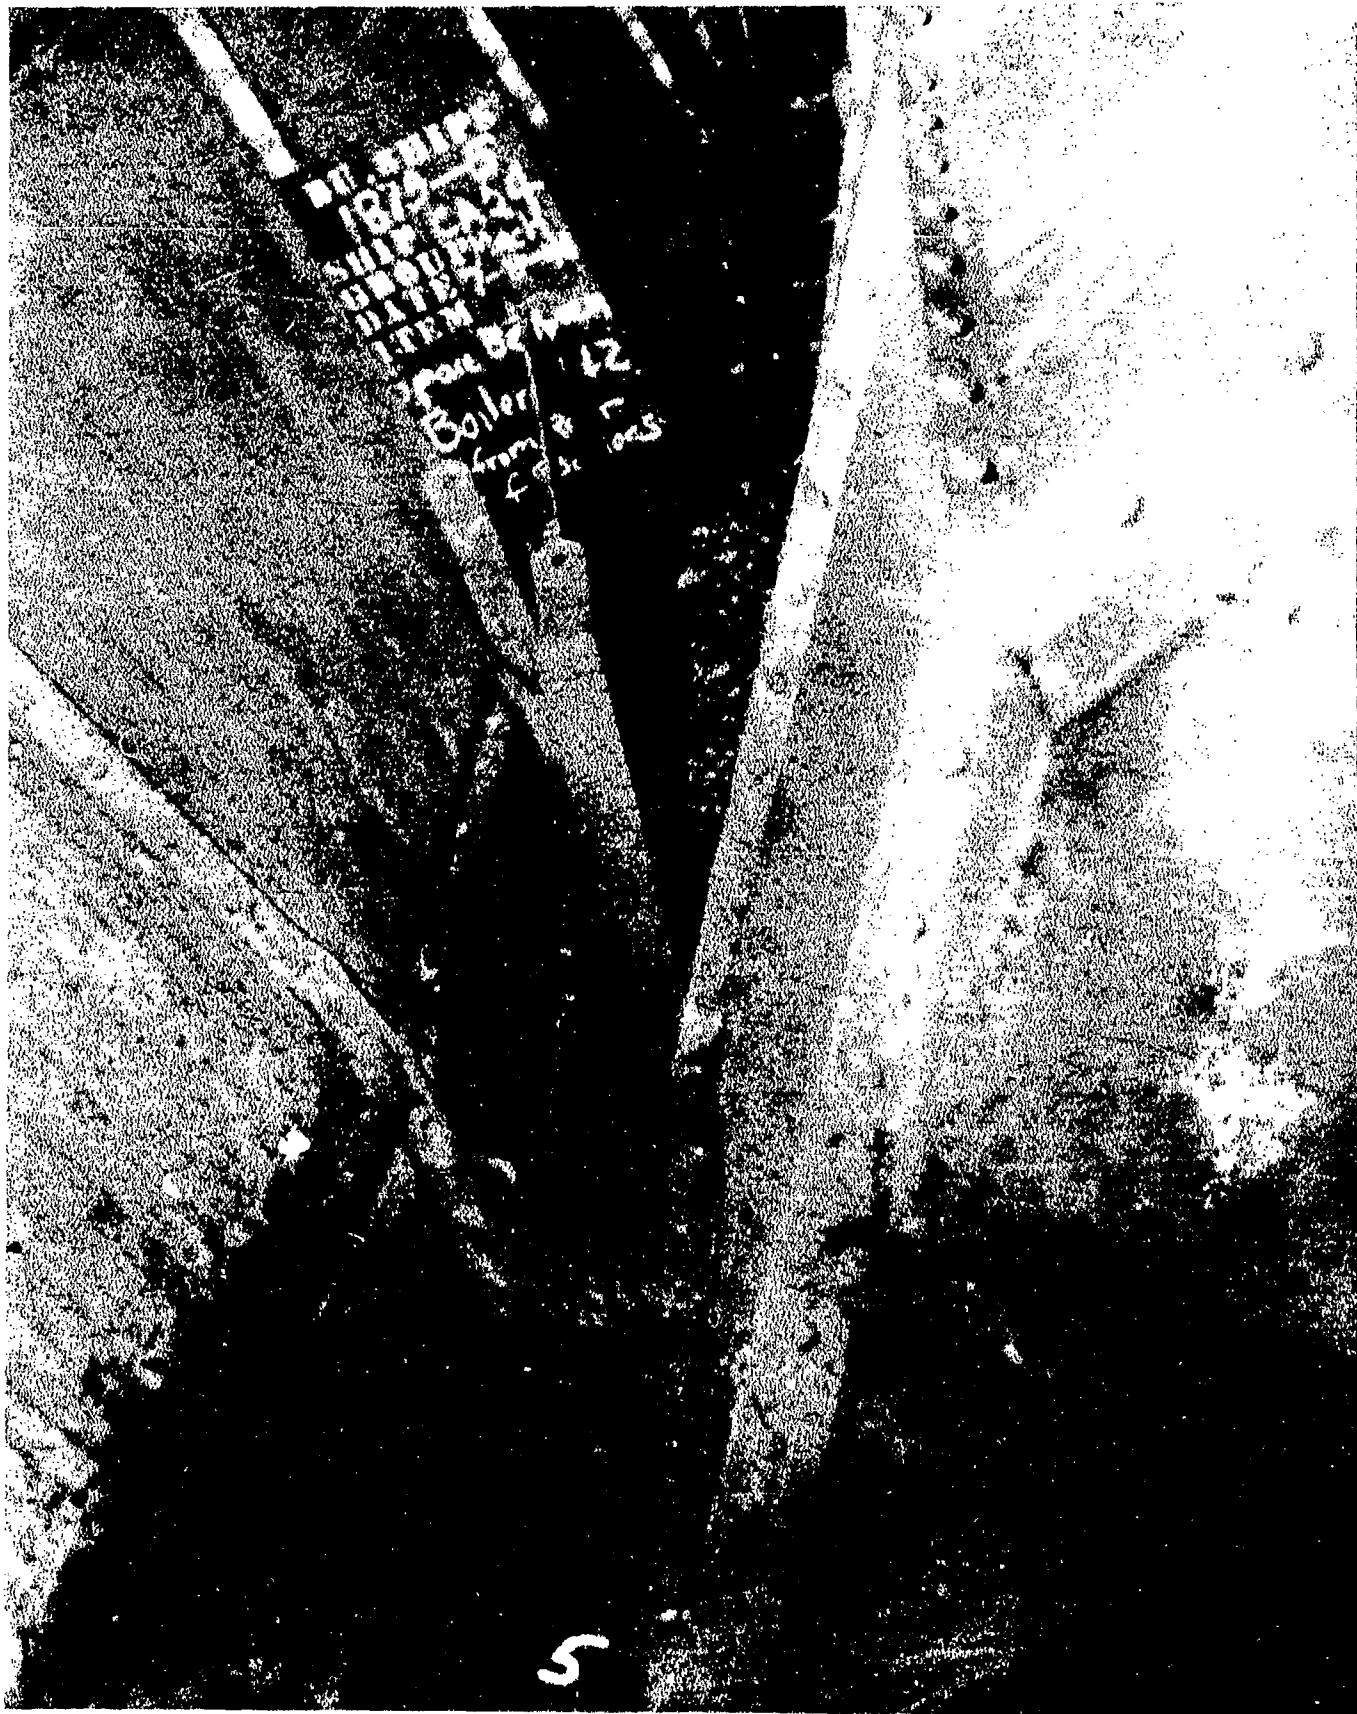
AA-CR-62-1879-5. Space between boilers #1 and #2 from rear.

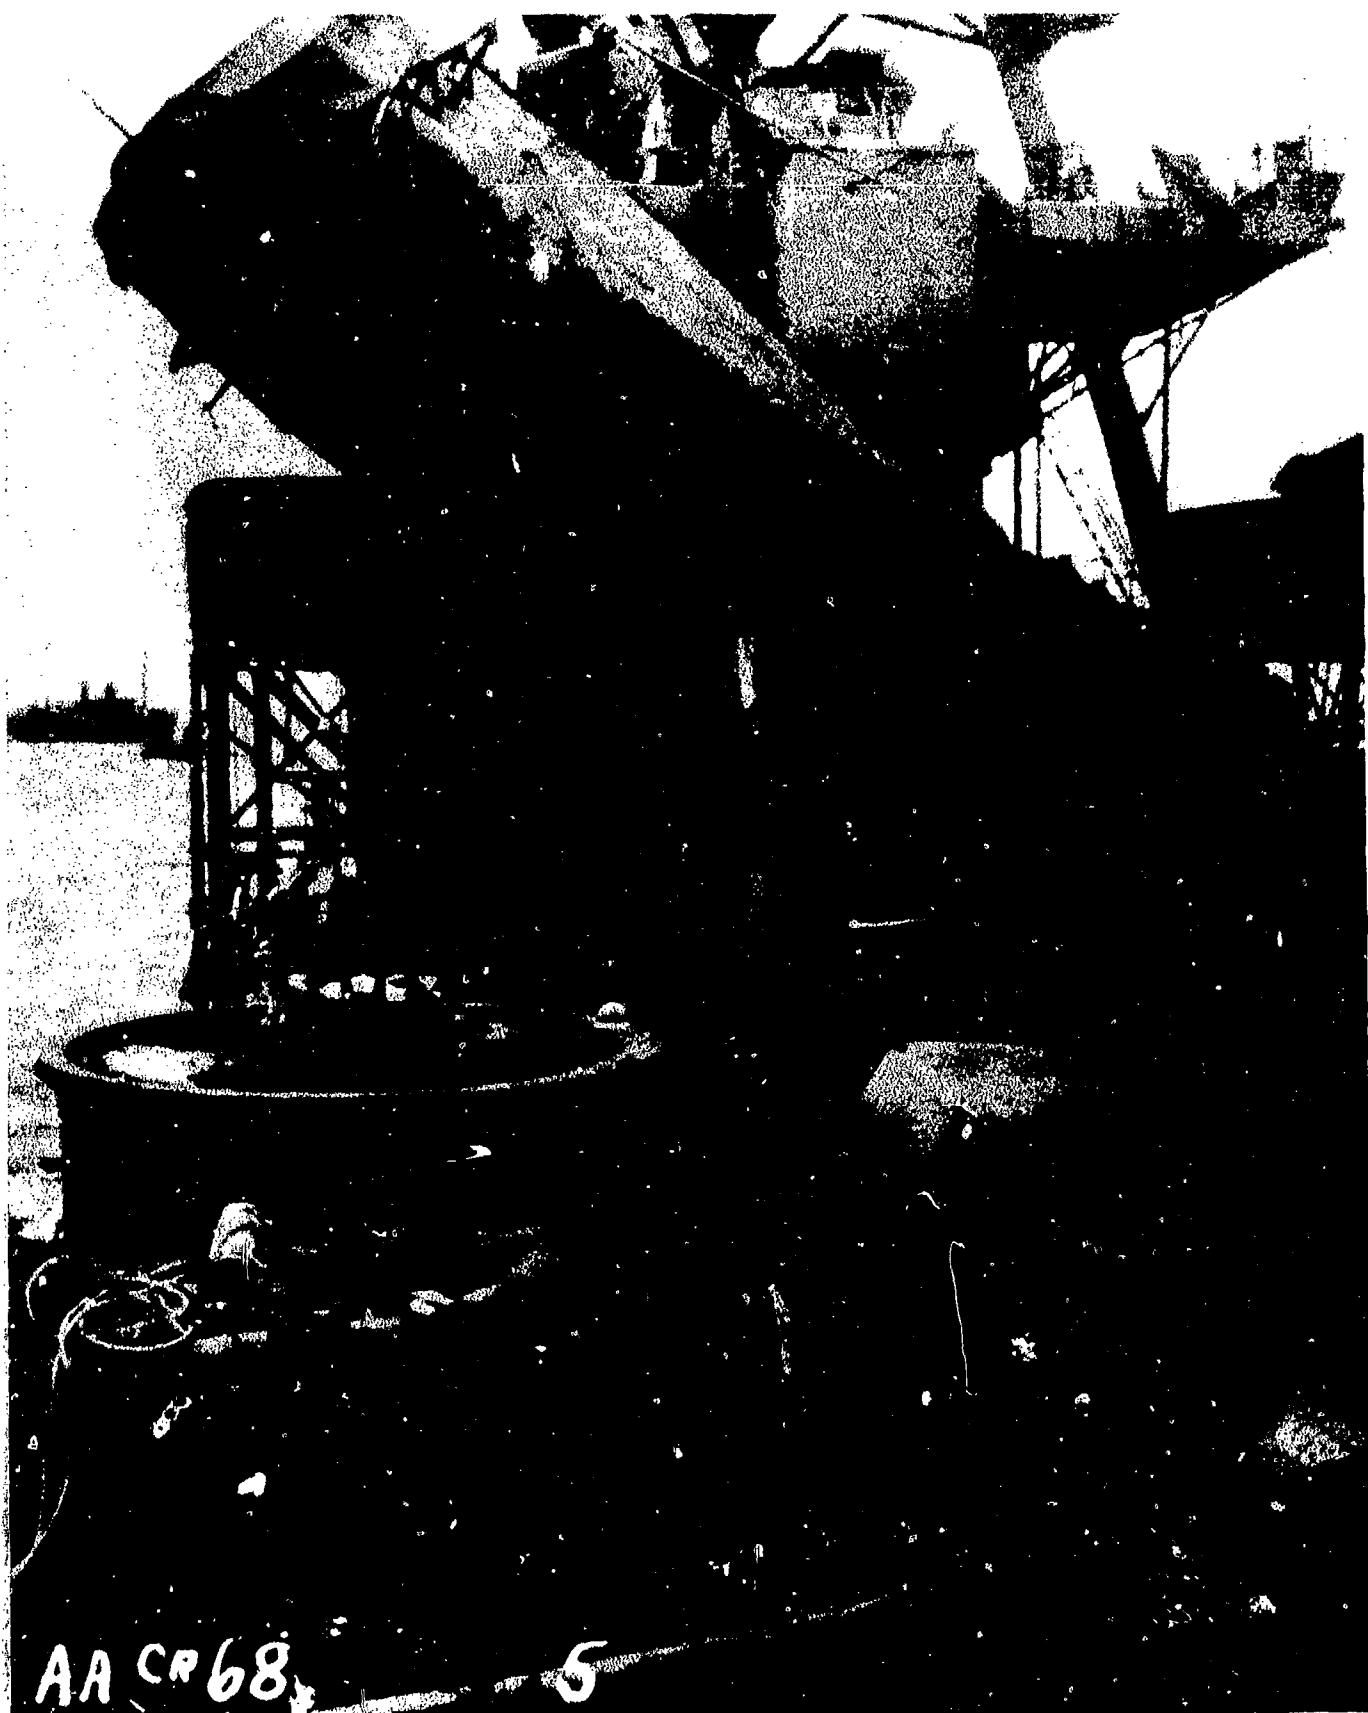
AA CR 68 5

AA-CR-68-1758-5. Forward stack.

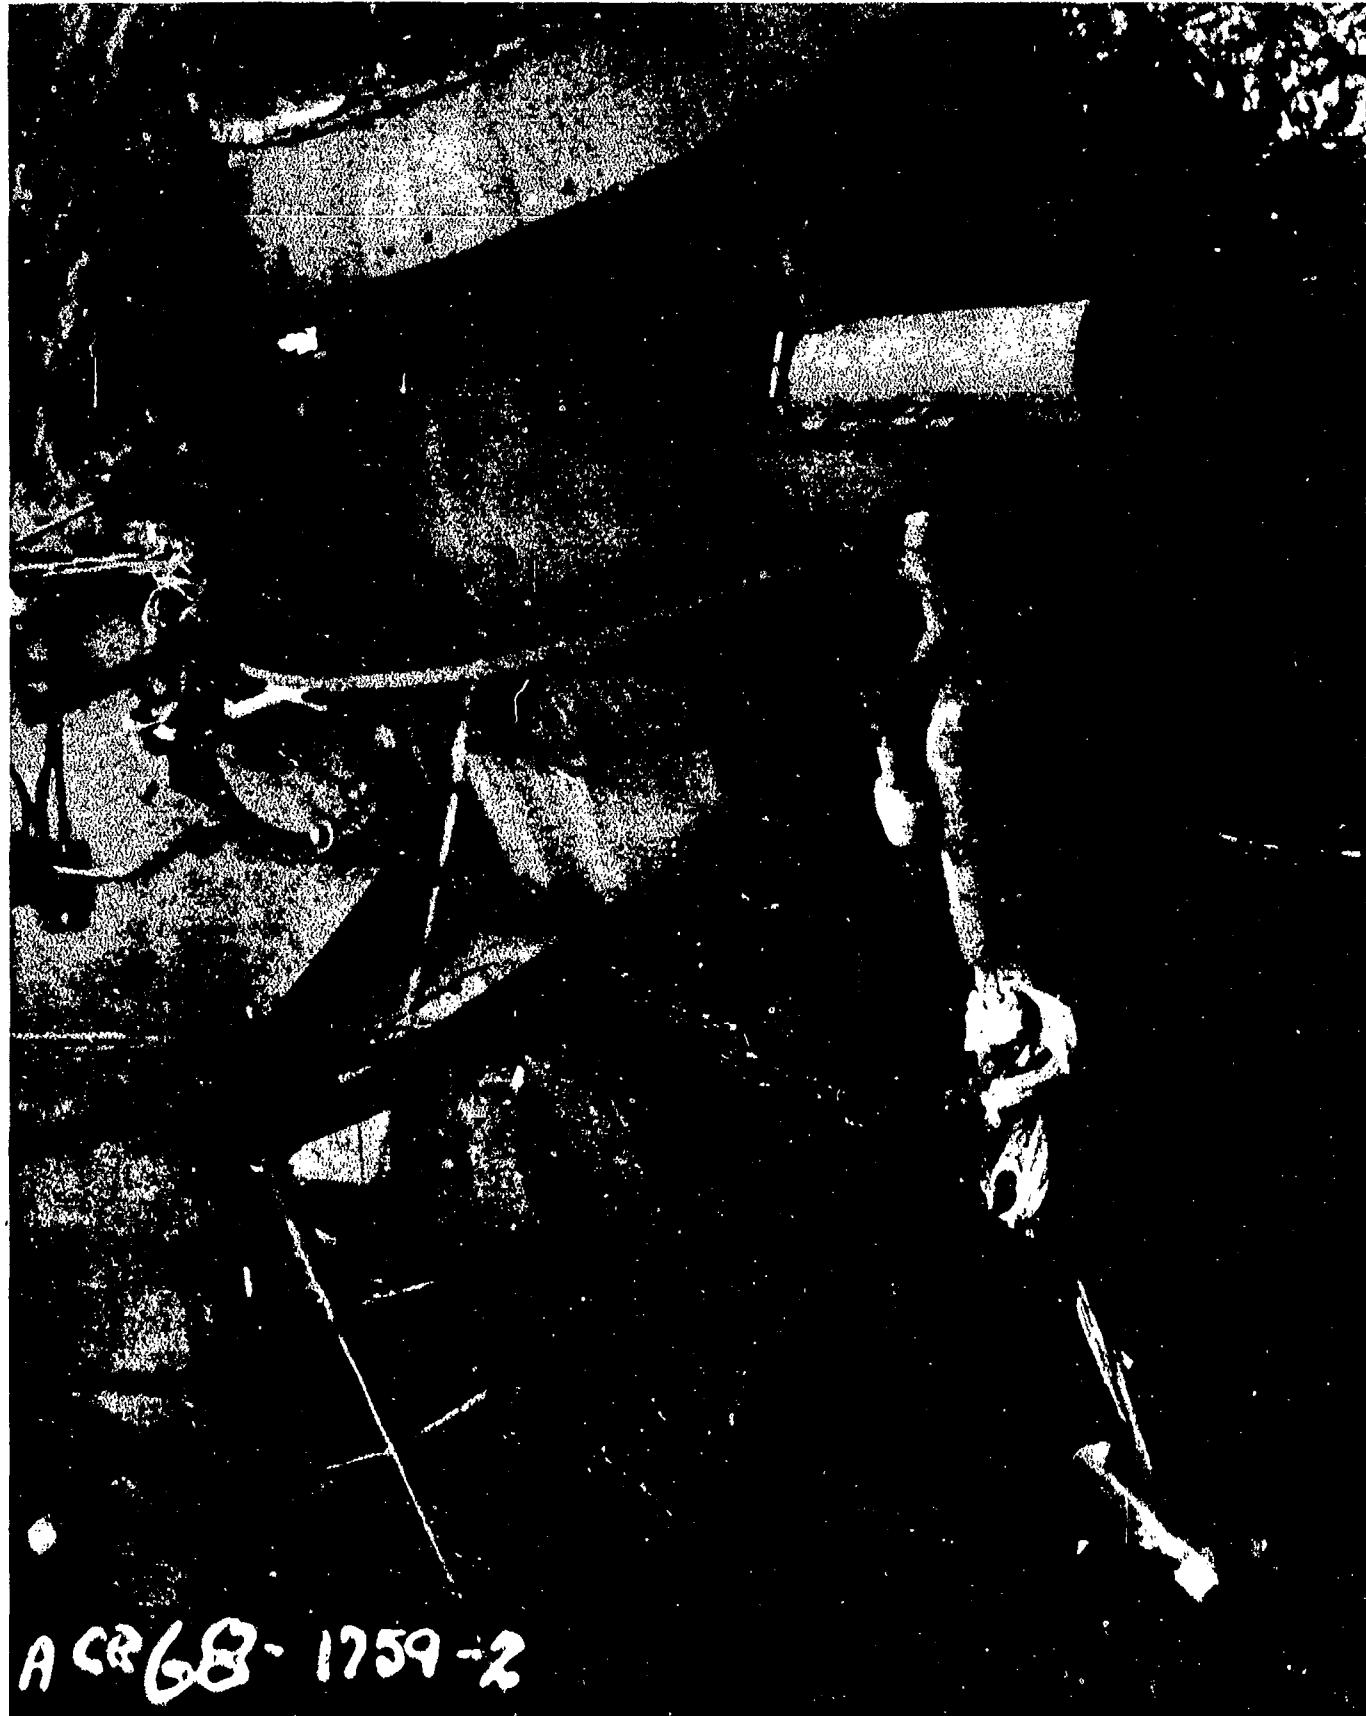
AA-CR-68-1759-2. Forward stack.
